## RESIDENTIAL ENERGY ANALYSIS REPORT

Client: Sample

Date of Inspection: 12/3/08

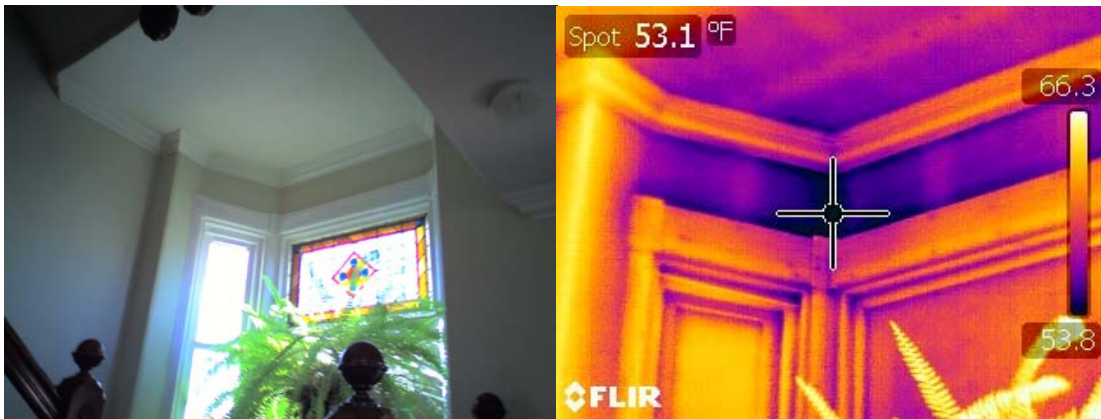
Stairway bay window header and ceiling.

Cooler wall temperatures, indicated by darker colors, show connection to outside and appear to reveal sagging or missing insulation. Warmer wall temperatures, indicated by lighter colors, appear to reveal increased insulation levels.

- **Exterior Walls:**  
The infrared scan appeared to reveal sagging insulation in the second floor walls and areas above windows. Some of the wall bays appeared to have no insulation at all. Most of the upper wall cavities in the second floor can be accessed and filled from the attic. Lower areas could be filled with cellulose or foam accessed from the outside by removing siding as necessary.

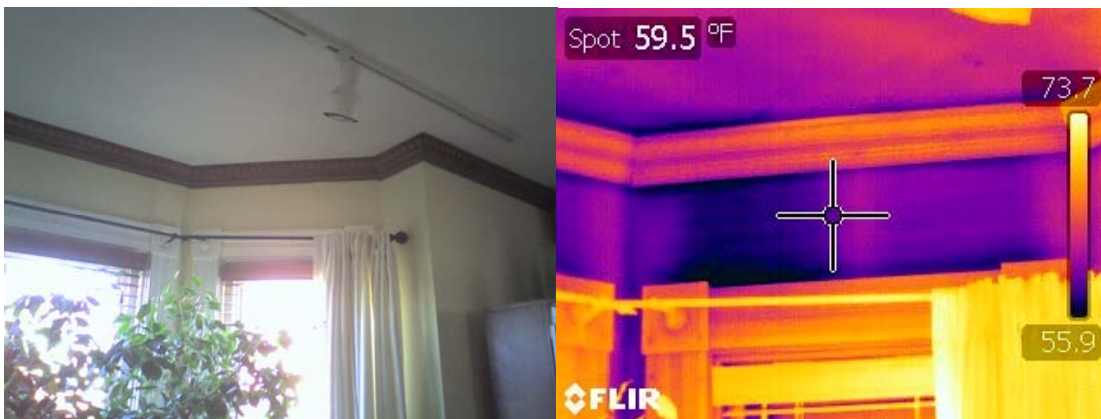
Dining Room window header.
